Maintenance Log

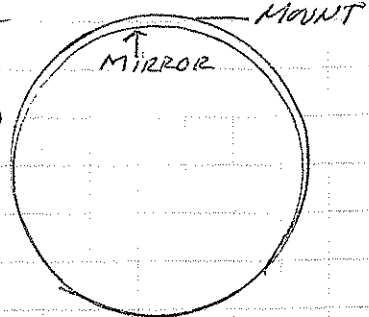
Pressure dropped ~ 400 mbar before 3 hrs! Brought system down to 1,000 mbar, then put ~ 100 mbar He. removed end mirror as in directions. Mirror looked very dirty w/ powder like spotting. Needs to be cleaned. looked like this →

O-ring also looked dried out needs replacement. Gilled

• Also seemed that mirror was not seated "nicely" in mount, it looked like it was sagging down off center

• O-ring has the following specs: $\phi 32 \times 2$ Viton

* Note: When new o-rings arrive & the system is opened up again, double check that mylar ~~ring~~ ring is in place.

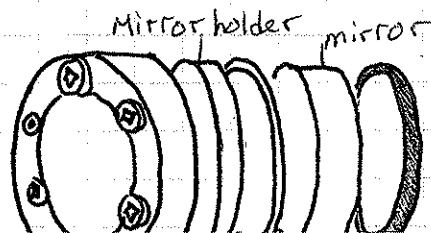
• Found a missing mylar ring, maybe I forgot it after the first install or maybe that was the problem the whole time. Charged system to > 2500 mbar @ 3:15 pm today.
• This is how the window assembly goes

O-Ring dimensions are 32x2 mm

• Just remembered that there was a lot of corrosion on the o-ring groove. This could lead to improper sealing of the windows. Once the helium arrives I'll plan to clean out the gaffe w/ Q-Tips & Ethanol (low moisture) & replace the o-ring w/ the one that's been cleaned w/ rubber rejuvenator.

• Helium arrived last Friday, today (Monday) I will clean the o-ring groove w/ acetone, blow off the mirror w/ compressed air (electronics grade) & replace old o-ring w/ "new o-ring" also will charge system to 2500 mbar for tomorrow's leak check w/ Di-Hexes.

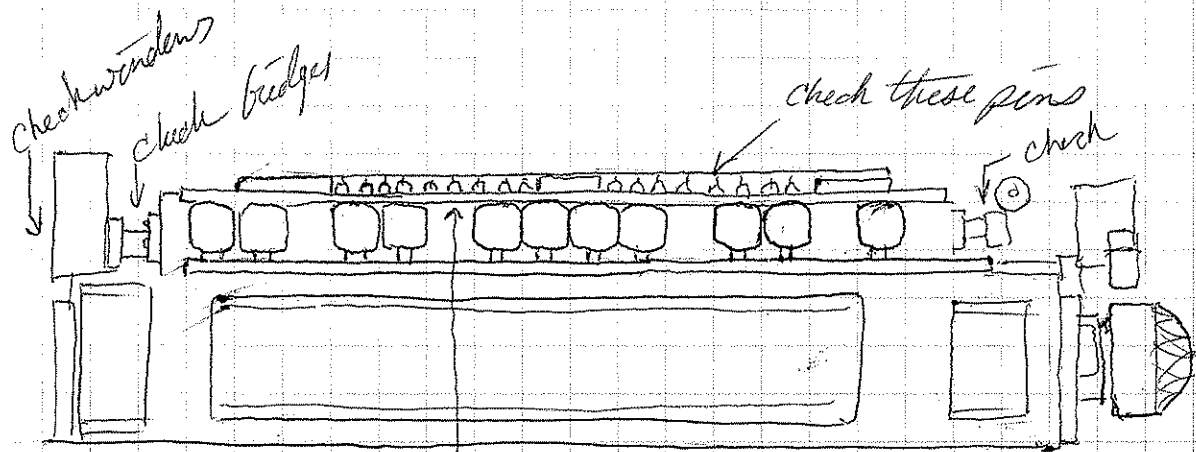
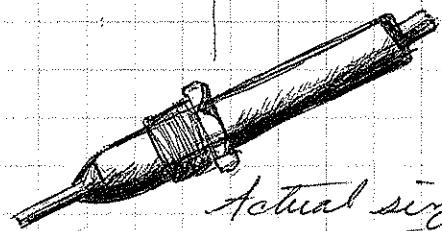
Actual size drawing of one of the pins

• Today we (Dr. Hines & I) are supposed to leak check in the following places:

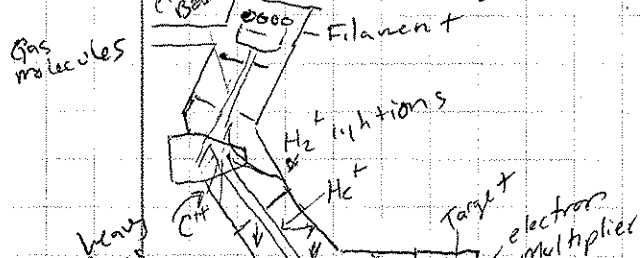
How it works, kind of cool.

Leak Rates

- Rear window mount ≈ 1 cc/sec $\times 10^{-8}$ Scale
- Front window mount ≈ 1.5 cc/sec $\times 10^{-8}$
- > 1 $\times 10^{-8}$
- ~~10X~~ rear window

← cover (marked) ≈ 4
Corroded plug $< 5 \times 10^{-8}$
 $\approx 2 \times 10^{-8}$
30% ← firm

Top - 6th From Rear - major leak.

• After testing the system it was clear we had some potential causes. My plan is as follows:

- 1) Get New o-rings, re-seal
